## CONSERVATION OF THE ANCIENT BOAT FROM THE SEA OF GALILEE

ORNA COHEN

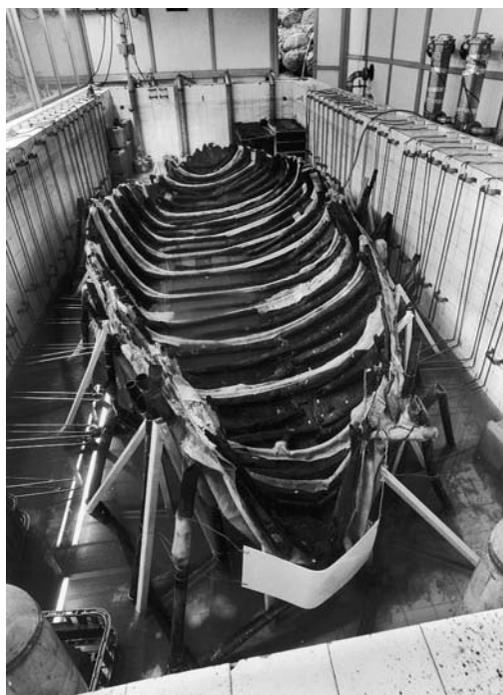
Fig. 1. The boat in the conservation pool, viewed from the stern. The heating elements are protruding from the wall along the length of the boat, and the circulation pipes are mounted at the ends of the pool.

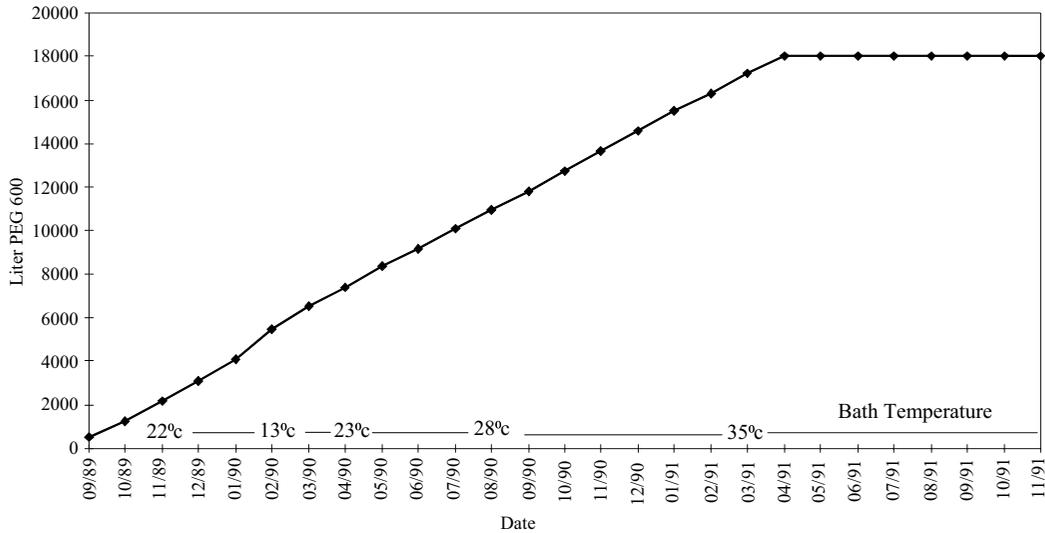
The PEG 600 was added to the water in the conservation pool in which the boat was kept at an average rate of 2.2% w/v per month until the final concentration was 50% w/v (Fig. 2). Following this stage, the pool was emptied and filled with water overnight. The low molecular PEG solution had a cleaning effect. All the mud that had not been removed manually came off with this solution, revealing previously indiscernible details. The boat was photographed and all our observations were recorded.

Fig. 2. Addition of PEG 600 to the pool. Average rate: 2.2% w/v per month, final concentration: 50% w/v.

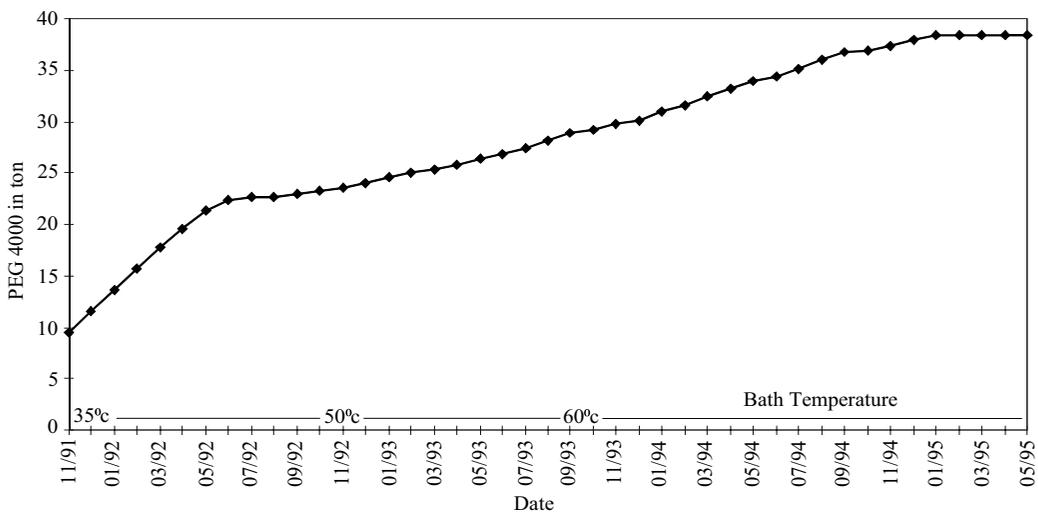
The second stage, involving treatment with PEG 4000, began after about a year's delay (due chiefly to the 1991 Gulf War).<sup>3</sup> We added PEG 4000, with an initial concentration of 20% w/v, subsequently raising the concentration at an average rate of 2% w/v per month, until the final concentration was 80% w/v (Fig. 3).

Fig. 3. Addition of PEG 4000 to the solution. Average rate: 2% w/v per month, final concentration: 80% w/v.

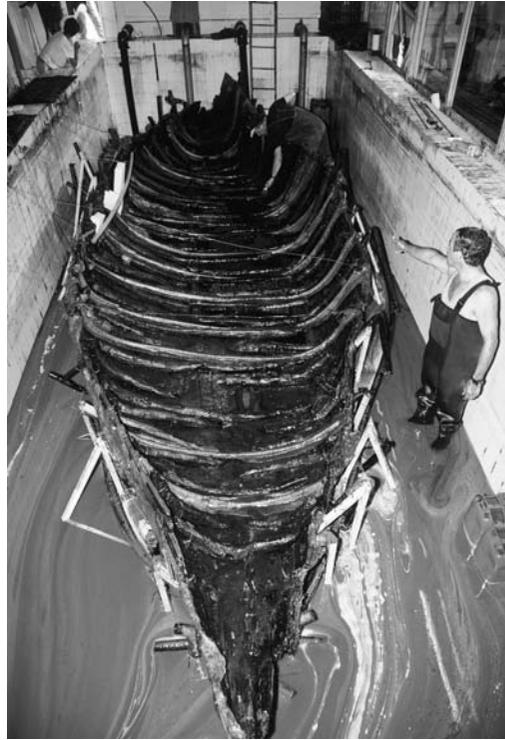
Six years after the beginning of the PEG conservation process, the moment finally arrived to remove the solution from the pool. Our foremost worry was whether the boat had survived undamaged during the almost four years that it had been hidden from our sight by the dark fluid. There was also a risk that, once the supporting liquid was removed, the vessel might fall apart or become warped. To our relief, the draining of the solution revealed an intact and stabilized boat (Fig 4).

Fig. 4. Removing the solution from the pool at the end of the conservation process viewed from the prow.

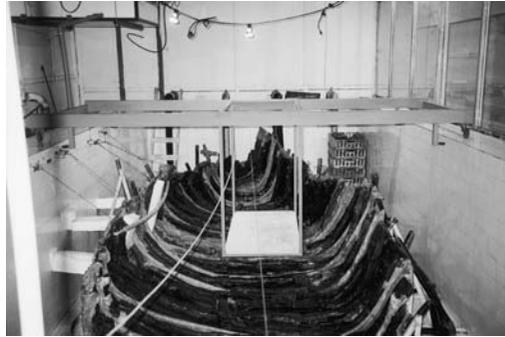
Fig. 5. The working bridge.

The boat is too fragile to carry the weight of a worker and it is not possible to reach all parts from the outside. A bridge of iron running on wheels along the edges of the pool was built in order to enable workers access to all parts of the boat (Figs. 5, 6).

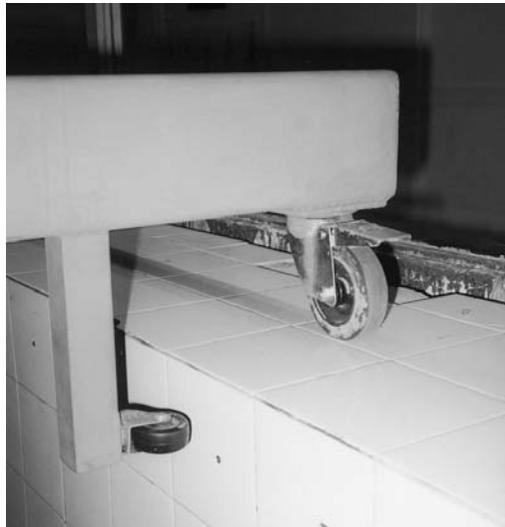
Fig. 6. The bridge wheels that ran along the pool's edge.

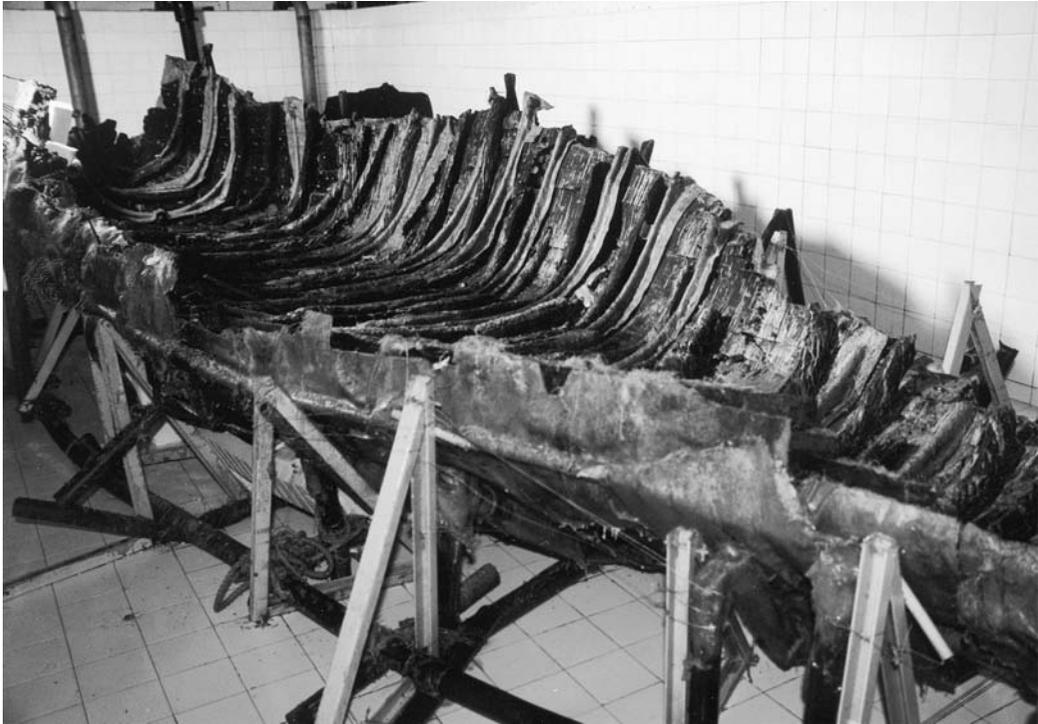
The frames built during the excavation and rescue operation in the field supported the boat within and without. Once in the conservation pool, fiberglass legs were fixed to the outer frames to stabilize the boat on the ground. The frames performed excellently for the rescue, but the outer frames were too thin under the bottom of the boat in the center. During the conservation process there was always some liquid in the pool, which supported the bottom of the vessel. At the end of the chemical process, as the pool was being emptied, some small movements were noticed in the boat's lower structure (Fig.7).

Fig. 7. The outer supports at the conclusion of the treatment.

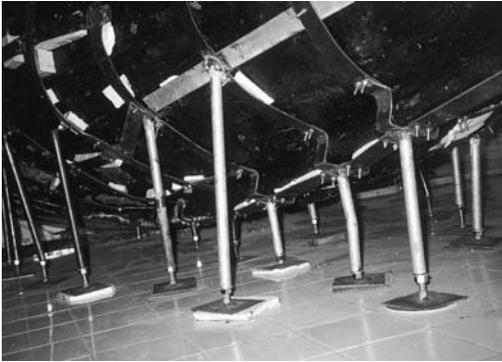
Fig. 8. Telescopic legs comprising bolt bars and nuts inside iron pipes. The pipes were gradually lengthened by slowly tightening the nuts.

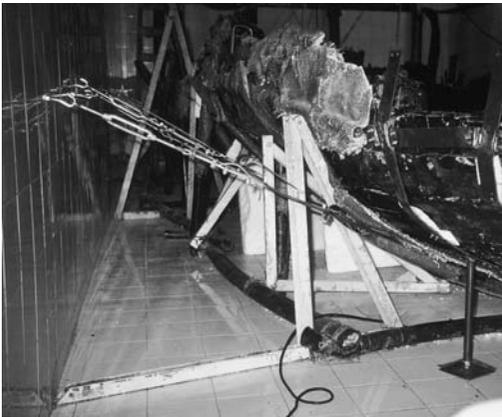
the PEG residue. These strips were connected to the pool's walls on both sides by steel wires and turnbuckles (cable tension device; Fig. 9). The boat was elevated millimeter by millimeter by adjusting each telescopic leg and tightening the turnbuckles. Gradually the boat was lifted (2–3 mm at a time) to 20 cm above the floor of the pool. All the fiberglass supports were replaced with metal supports on 130 telescopic legs, which enabled the boat to be raised so that it could be cleaned and studied from below. The excess PEG was cleaned from the wood surface using a hot-air gun and absorbent paper tissue.

Fig. 9. The turnbuckles that lifted the middle of the boat from the floor.

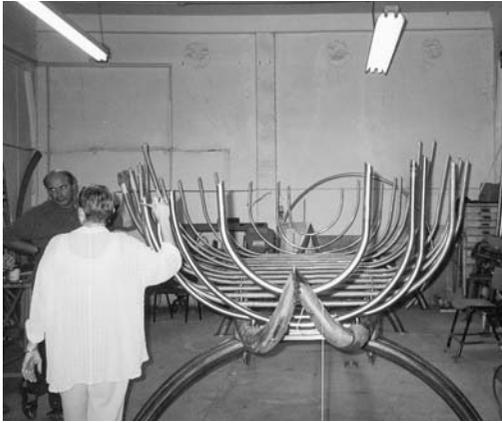
Fig. 10. The stand at the factory.

The stand is constructed of stainless steel with a matt surface (Fig. 10). A long elliptic base supports 18 frames which transverse the boat, 5–40 cm from its surface (Fig. 11). The wood is gently supported by 400 'fingers' that are attached to these frames. This specially-developed device can be adjusted to any angle and length along the frames. In delicate areas, mainly at the bottom and along the keel, 1 mm metal strips were attached to the wood, and these are mostly invisible to visitors. The metal areas touching the boat were covered with balsa wood 1 mm thick (Figs. 10, 11).

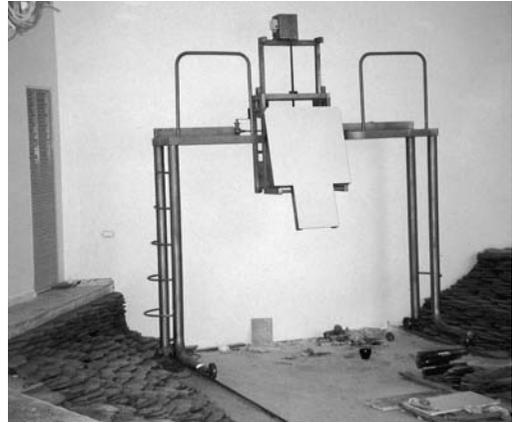
Fig.12. Working bridge at the museum.

A working bridge was installed at the exhibition, which will be necessary for future restoration and maintenance of the boat (Fig. 12). Unfortunately, there was no space to hide it from view and it became part of the exhibition.

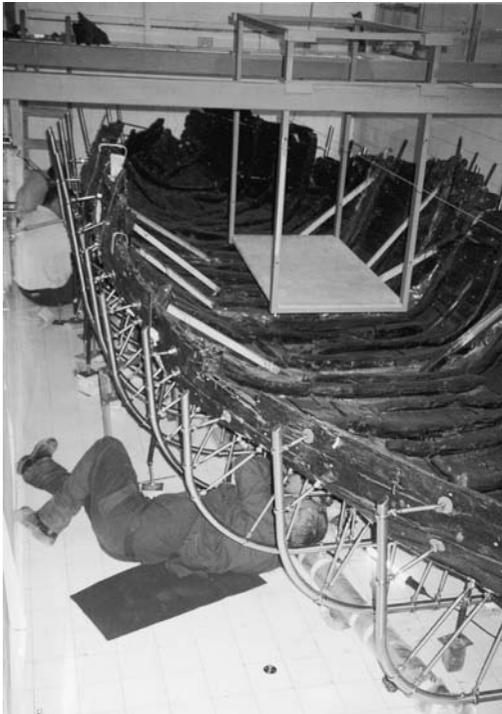
Fig. 11. Adjusting the stand to the boat.

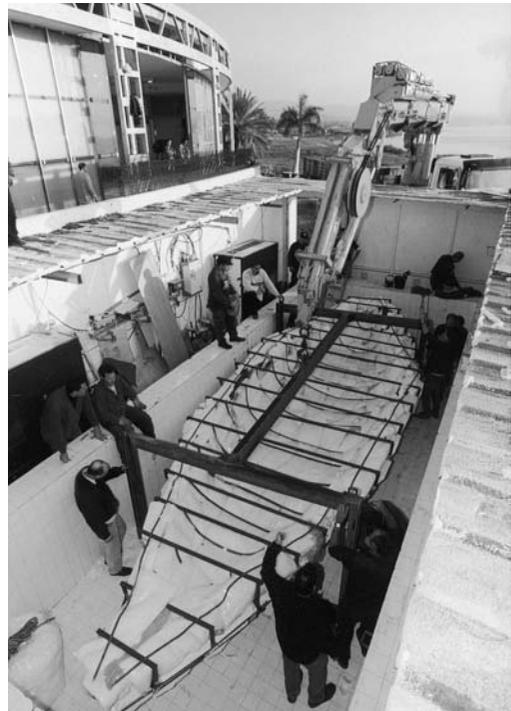
Fig. 13. The crane attached to the packaged boat for transportation into the exhibition hall.

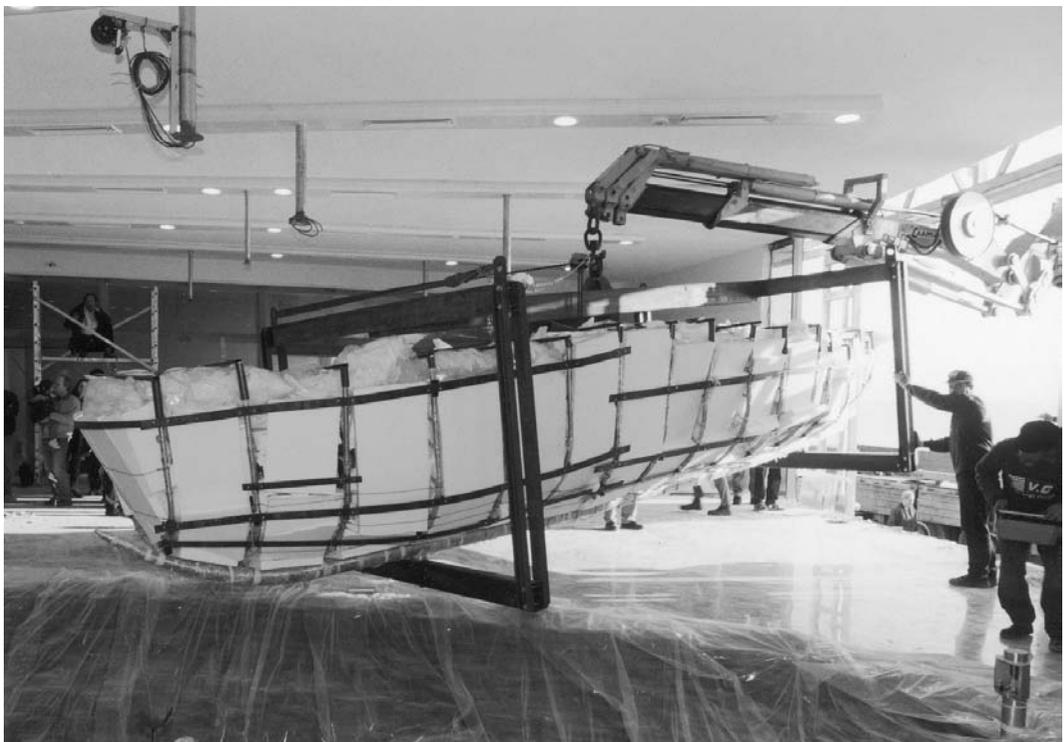
Fig. 14. The crane carrying the boat through the eastern wall.

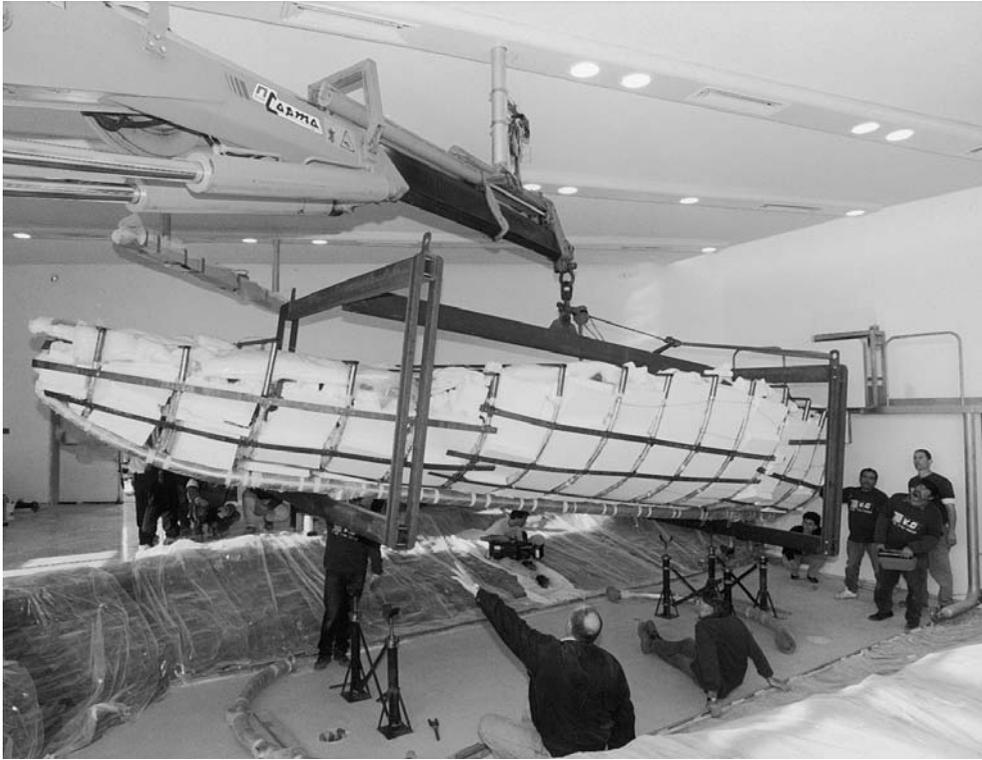
Fig. 15. Lowering the boat to its final position.

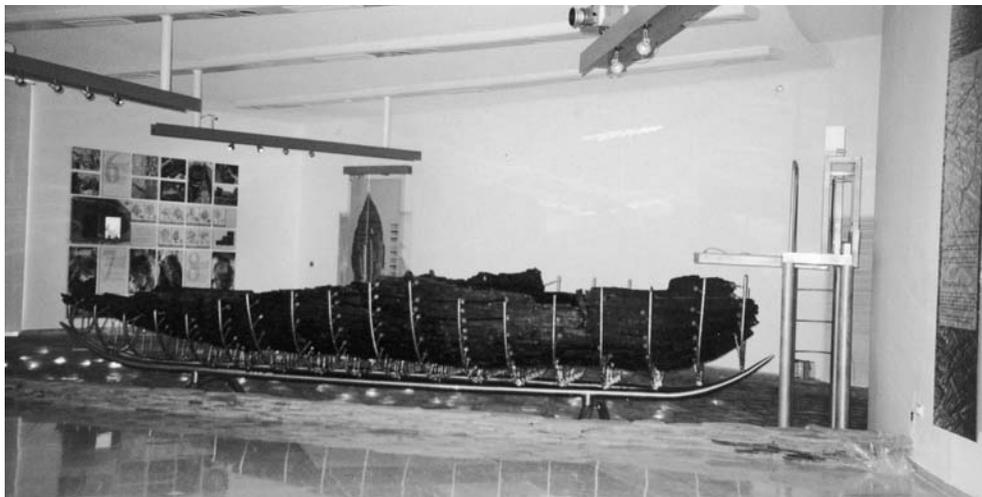
The following day, the environmental conditions were stabilized and the packing materials removed. The transportation had not damaged the boat and for the first time it could be viewed in an open space. Exactly 14 years after the first day of the excavation, the boat was secure (Fig. 16).

Fig. 16. The boat in the new exhibition hall.
