ANASTYLOSIS OF THE OBELISK IN THE EASTERN CIRCUS AT CAESAREA MARITIMA¹

YORAM SA'AD

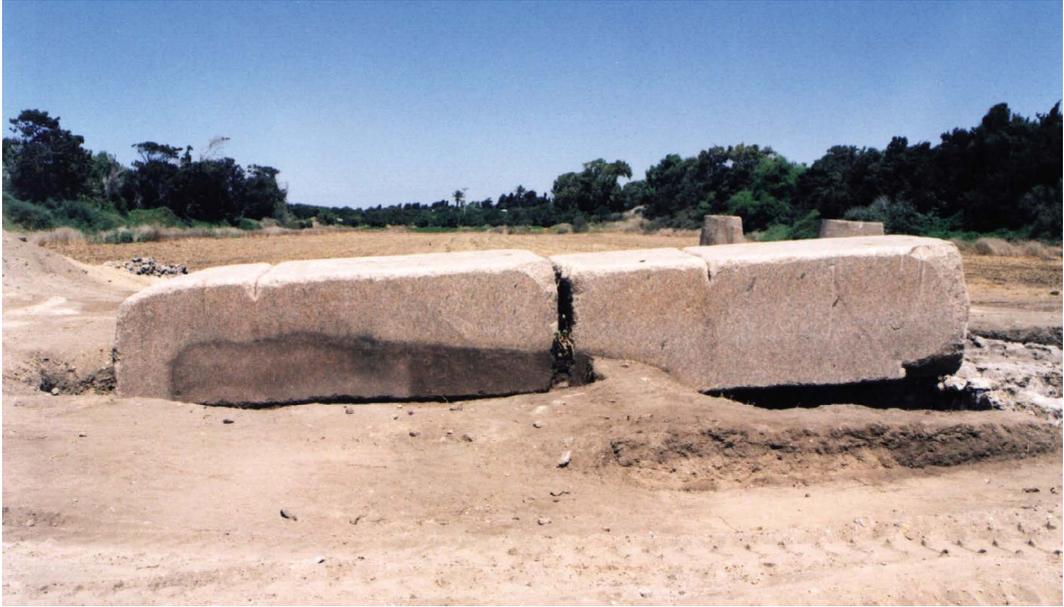
Fig. 1. The obelisk shaft before it was moved, ahead of anastylosis, looking north.

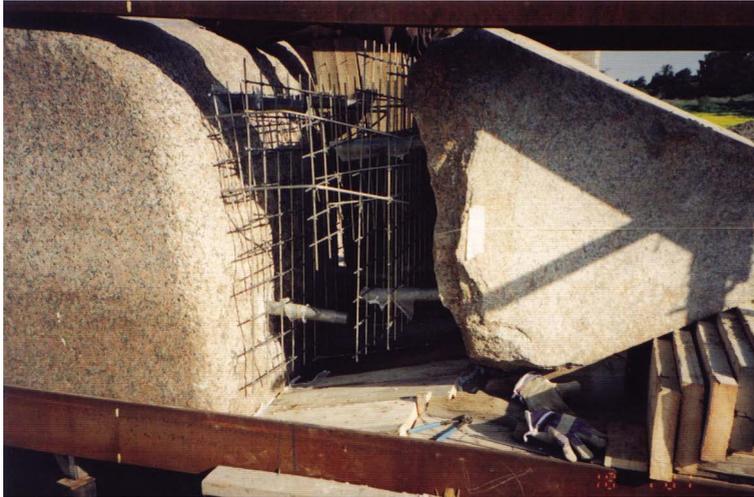
Fig. 5. The connection point of the pyramidion to the upper part of the shaft.

The *pyramidion* and the upper part of the obelisk were to be connected by casting a reconstruction of the missing part (Fig. 5). This required a decision, the result of which could only be appraised after the obelisk was standing and the scaffolding and other constructions removed. The first question was how to ensure that the face of the *pyramidion* and the face of the top segment of the shaft of the obelisk were in the same positions as they were originally, before they were cut apart in antiquity. The issue was resolved when we discovered a saw mark at the edge of one of the faces of the *pyramidion*. The saw mark was on the side facing upward and therefore would have been made after the obelisk fell. Thus, we could tell which face of the *pyramidion* was the upper, i.e., the eastern, side before the obelisk’s fall.

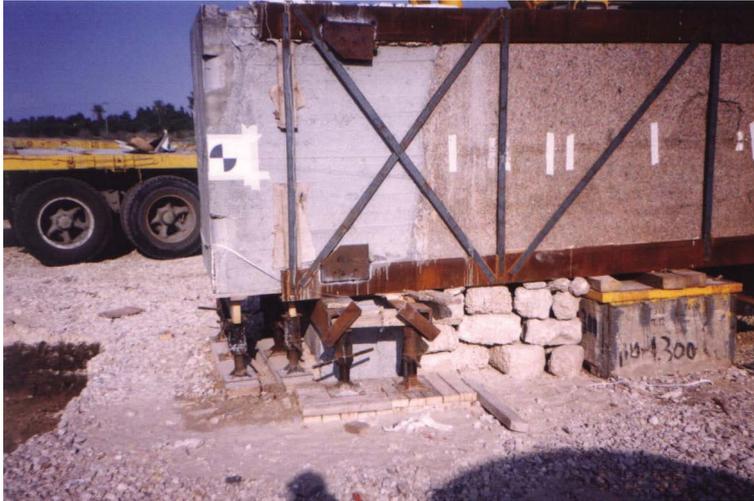
Fig. 6. The support for the bond between the granite and concrete before lifting.

The concrete's inability to bond with the granite led to concern that pressure exerted during the lifting of the obelisk might cause the reconstructed concrete elements to detach from the granite. To prevent this, a number of steps were taken. The two segments of the obelisk were 'embraced' with temporary stabilizing supports consisting of steel L-beams laid on the corners of the segments, and metal bars were welded to the L-beams. To prevent movement of the components of the stabilizing supports, they were 'locked' to the reconstructed concrete by means of anchors. To improve the hold of the supports on the shaft of the obelisk, cement grout was injected between the L-beams and the reconstructed sections. Wooden pegs were also inserted between the granite and the L-beams. In addition, a temporary concrete and stone stabilizing support was created on which the center of gravity of the concrete reconstructions would rest. Piles of sand were prepared at the lower end of the two segments to reduce friction and the risk that the obelisk would shatter when raised (Fig. 6).

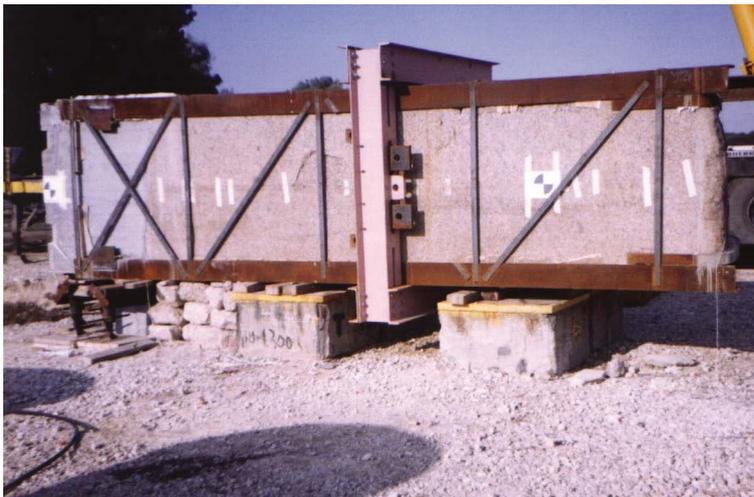
Fig. 7. The lower segment of the shaft, ready for anastylosis; note the cord along the central horizontal axis of the side of the shaft.

The day the bottom segment of the obelisk was raised (December 5, 2000) the carrying frame was attached to it, along with iron chains from one side of the shaft to the other and around the bottom. The chains were tightened and the links were counted to ensure an equal number of links on all sides, which, if equal after raising, would mean that the shaft

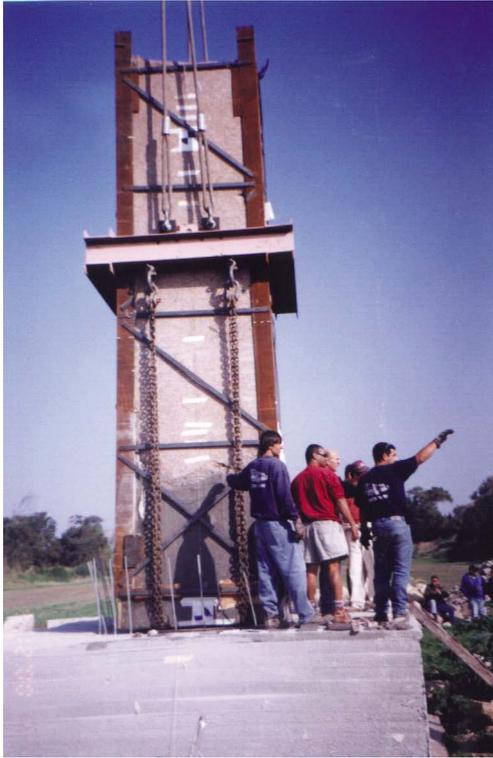
Fig. 8. The lower part of the shaft, in place.

had been precisely achieved, and that on the east–west axis, a small eastward deviation remained at the top of the bottom segment (c. 12 mm). However, in consultation with the crane operators and expert bridge-builders assisting us on site, and in view of the lack of symmetry of the shaft of the obelisk, we decided to forego further adjustment (Fig. 8).

After the lower segment was in place, the temporary stabilizing supports were dismantled. The space that was left between the lower segment and the pedestal was filled with cement grout, and subsequently, a casing consisting of B400 concrete and measuring $1.20 \times 2.26 \times 2.26$ m was created around the bottom segment to reconstruct the bottom portion of the shaft (Fig. 9). The concrete was reinforced with stainless steel rods. Scaffolding was then constructed surrounding the now-standing bottom portion of the shaft, to a height of 9 m.

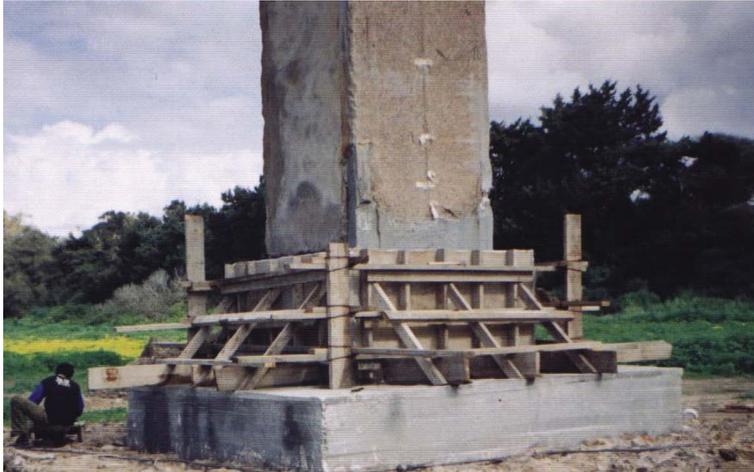
Fig. 9. Casting the casing around the base, looking southwest.

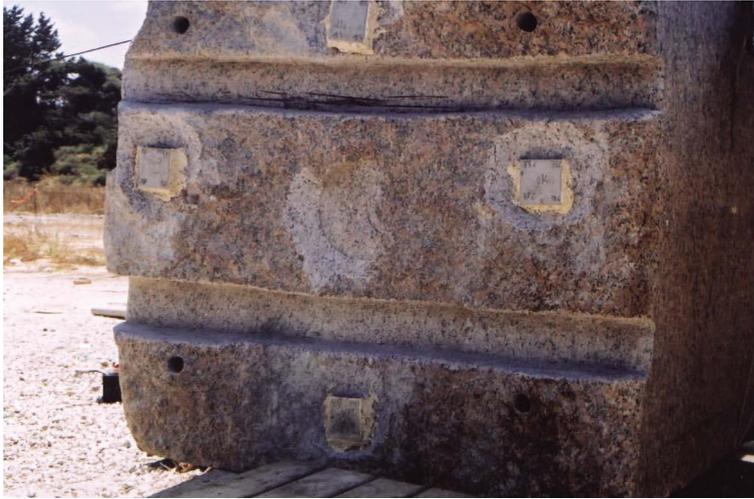
Fig. 10. The grooves (channels), sawed into the bottom of the upper part of the shaft and the support plates.

We therefore had no choice but to saw grooves (channels) at the bottom of the upper segment at the point where the lifting bands would be inserted (Fig. 10), in order to reduce the protrusion of the bands in the space between the two faces of the fracture. Preparation of the face of the fracture for this phase involved cleaning the stone with sandblasting, removal

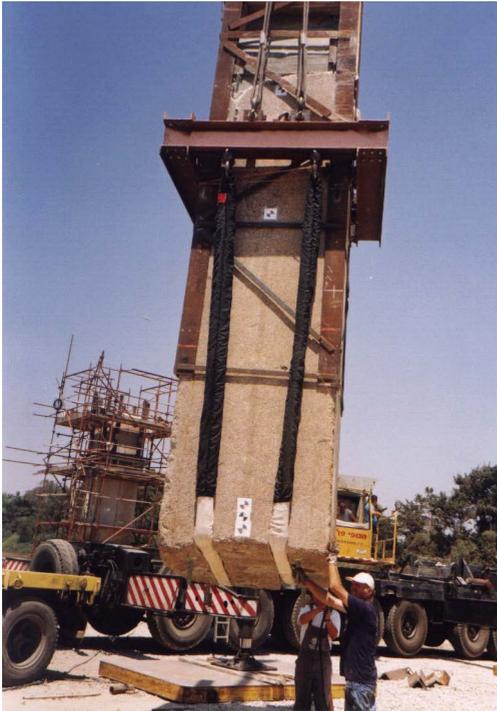
Fig. 11. Raising the upper portion.

We raised the upper segment on June 18, 2001. We then measured the long axes to determine the verticality of the shaft, which revealed a pitch of c. 12 cm. A number of attempts were made to correct the situation, which included using weights, stretching the lifting cables and adding or subtracting links to the cable's suspension system. To make these adjustments, the upper part was laid back on the ground a number of times, but we were unable to significantly reduce the pitch. At that point, we decided to raise the upper segment and attempt to set it in place and adjust it without the use of the weights or the chains (Fig. 11). The upper part of the shaft was lowered into the frame and with the help of wooden wedges placed between the shaft and the frame (Fig. 12), we were able to fit the outer faces of the fracture together. The shaft was stabilized on the three support points, as expected (west, north and south), and the titanium rods were inserted into the drill holes. With the release of 35% of the weight, as had been pre-determined, we stopped lowering the segment to take measurements by means of two theodolites, which were placed in the same positions as during the raising of the lower segment.

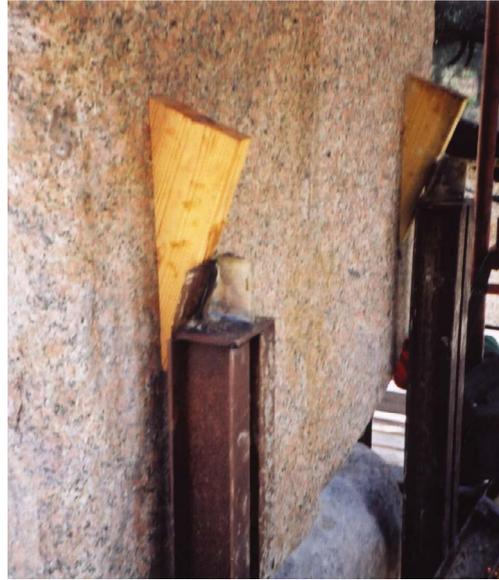
Fig. 12. Horizontal adjustment of the upper part using wooden wedges.

the eastern support point. A calculation was made of the correction necessary, based on a formula we had developed. For the adjustment we added a stainless steel plate 9.5 mm thick to the northern support point, a 10 mm plate at the eastern point and a 5 mm point at the western point. The final measurement showed that the obelisk was precisely vertical (Fig. 13).

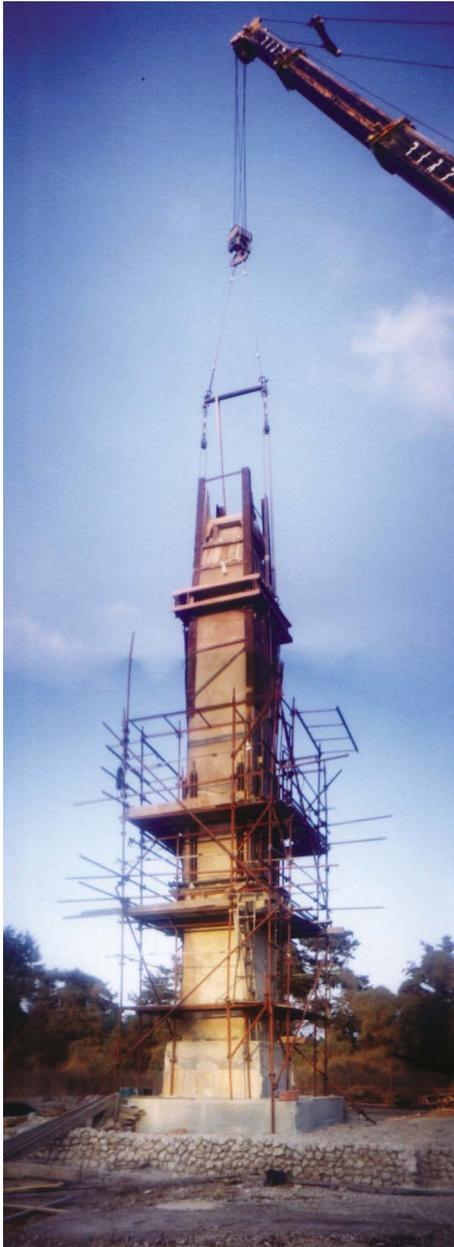
Fig. 13. The upper part of the obelisk in place, still suspended from the crane.

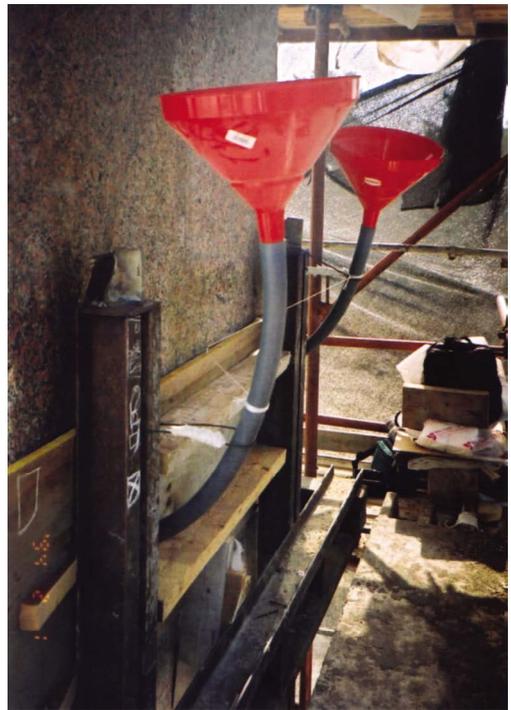
Fig. 15. Injecting the adhesive into the fracture space.

Various products from a number of manufacturers were examined and testing was carried out on miniature models. All types tested included two components: the resin (liquid or powder) and the hardener (liquid). The large space between the fracture faces required the addition of a filler to the resin to improve workability and the ability to withstand pressure/pull. After consulting the manufacturer, we added sifted sand and aluminum powder as an aggregate. To ensure that the outcome of our testing on the smaller model was not random, we repeated the test on a larger model, including simulation of the slant and the restrictive conditions pertaining to the obelisk itself (Fig. 15).

The workability of the adhesive selected was short (20–25 minutes). The space had to be filled in a continuous, single attempt so that the adhesive would not harden and obstruct the pipes or the framework. Therefore, the mixing of the materials and their injection into the funnels was done quickly. When the glue emerged through the pipes we used as monitors, we knew that adhesive had spread well inside the space of the fracture. Approximately 320 kg of adhesive were prepared for injection.

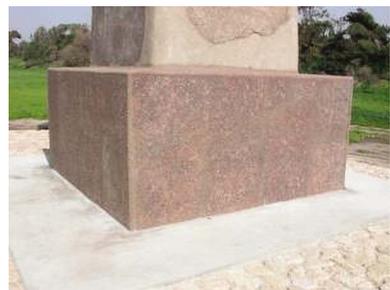
Fig. 16. The base after coating.

The last stage of anastylosis was to coat the cast reconstructed portions of the shaft. We had planned to cover the base only after the scaffolding was removed. A study of the matter led to two alternatives: (1) covering with prefabricated tiles of granite or granite-like material; or (2) coating with a technique similar to plastering.

The first alternative was rejected after it was realized that the availability and cost of prefabricated granite-like plates was prohibitive. There was also concern over the sensitivity of such plates to the climate and the risk of vandalism. We therefore decided on the second alternative, which involved creating a mixture of materials that would be suitable for application. A number of samples were made to study the components, adhesives and appearance. The mixture selected consisted of crushed granite (maximum aggregate size 4 mm), crushed limestone (same maximum aggregate size) and Acrylic-33 diluted in water. The resulting mixture generally resembles the granite of the obelisk, but nevertheless can be clearly differentiated (Fig. 16). The coating was applied to a thickness a few millimeters shy of the original dimensions of the obelisk's surface. To protect the monument from sandstorms, salt crystals and

erosion due to environmental or climatic factors, the surface was treated with a material that is water repellent but allows the escape of water vapor. The material, Rhodia H224, was diluted with ethyl alcohol at a ratio of 1:7.

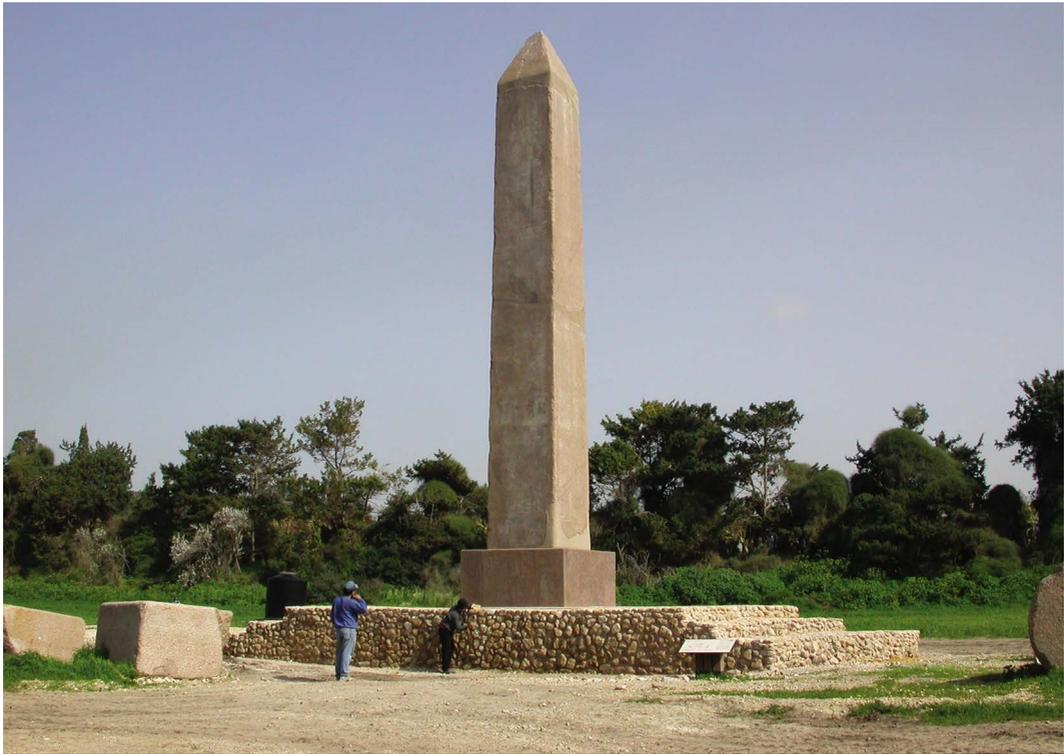
Fig. 17. The obelisk after anastylosis.

After coating was completed, the supports were removed from around the base, allowing the entire monument to be seen for the first time with no visual obstructions. Only then could we assess the outcome of the entire project. At that point, the project was halted, because unexpected delays during the process had led to the expenditure of the entire budget. Therefore, the coating of the rest of the base and the reconstruction of the *spina* were postponed until early 2004. By February of that year, the work was completed (Fig. 17).
